No. 2 Firhouse Road and the former 'Morton's The Firhouse Inn', Firhouse Road, Dublin 24: **Invasive Species Survey Report**

By: Louise Mac Elwain Date: 28 April 2022

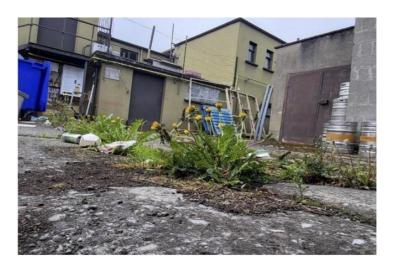
Fig. 1 Dandelion and other non-invasive species growing to rear of site.

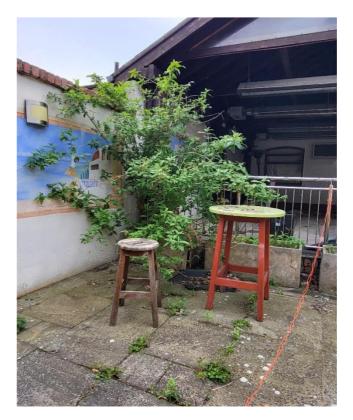
No species listed on the Third Schedule of the European Communities (Birds and Natural Habitats) Regulations, 2011 (S.I. No. 477 of 2011), were found within the boundary. *Buddleja davidii*, an invasive species with a Medium Impact risk, was noted in abundance. Mature Sycamore (*Acer pseudoplatanus*) is another Medium Impact risk species which occurs in the treeline immediately adjacent the site.

Fig. 2 *Buddleja davidii*, a nonlisted invasive species recorded in the former beer garden.

can lead to erosion problems due to its shallow roots. It can also outcompete native vegetation. Control of *Buddleja davidii* is quite straightforward. It may simply be grubbed up during dry periods and the cut material may be mulched and disposed of as per any cut woody material. Herbicide such as Glyphosate or Triclopyr may be applied to leaves or cut stems to kill plants in-situ. As the other invasive species occurring here (Sycamore) occurs outside the site, no action on this species is recommended.

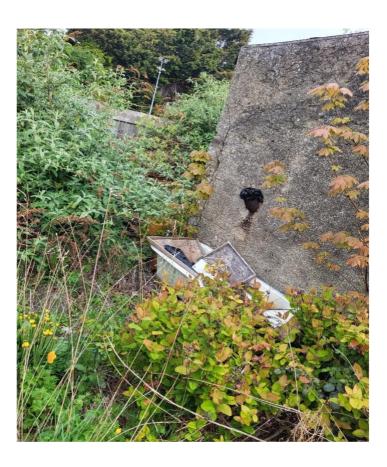
Fig. 3 Buddleia (to rear of photograph) and a number of other non-invasive species including Tutsan.

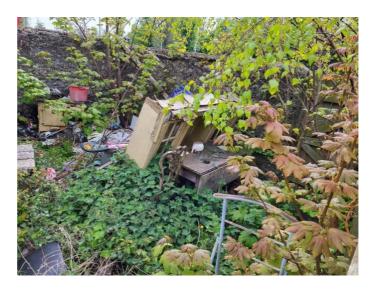
Fig. 4. Nettles and other non-invasive species among discarded materials to the rear of the site.
